AIR FORCE REUSABLE ROCKET ENGINE PROGRAM

**XLR129-P-1
FINAL REPORT
AFRPL-TR-71-1 VOL I
JANUARY 1971**

**Robert R. Atherton, et. al.
Pratt & Whitney Aircraft
Division of United Aircraft Corporation
Florida Research and Development Center**

**Prepared Under
Contract F04611-68-C-0002 for
Air Force Rocket Propulsion Laboratory
Edwards Air Force Base, California 93523**

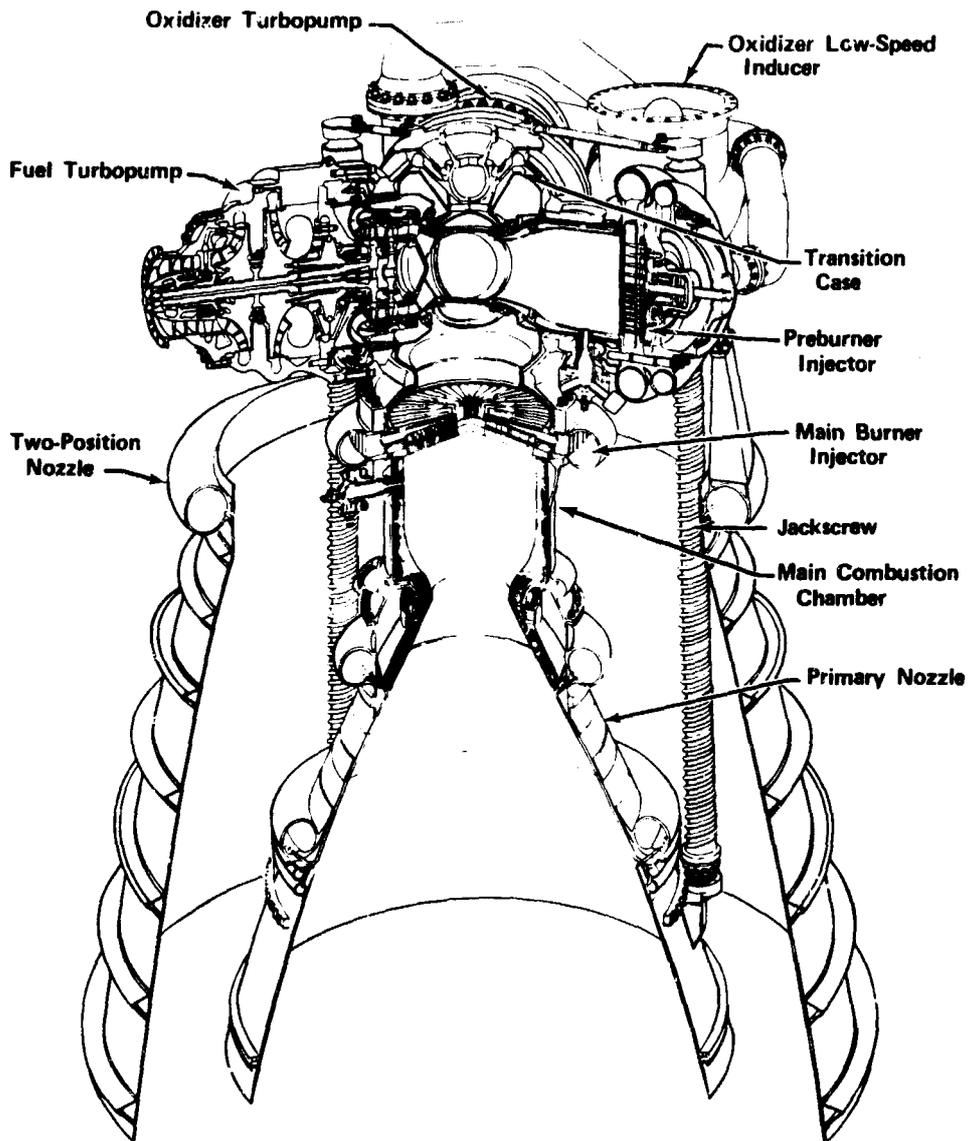
Figure 2. XLR129 Demonstrator Engine

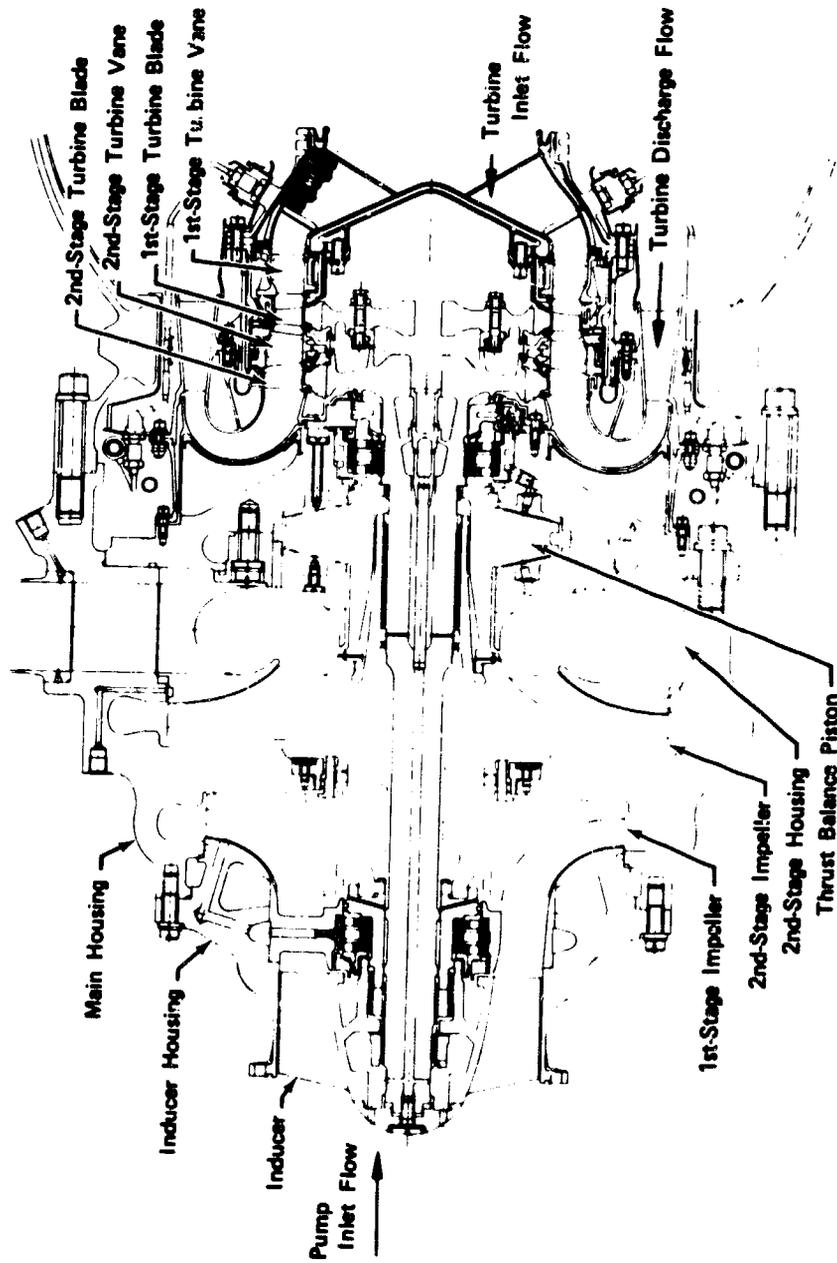
Figure 9. Fuel Turbopump Assembly

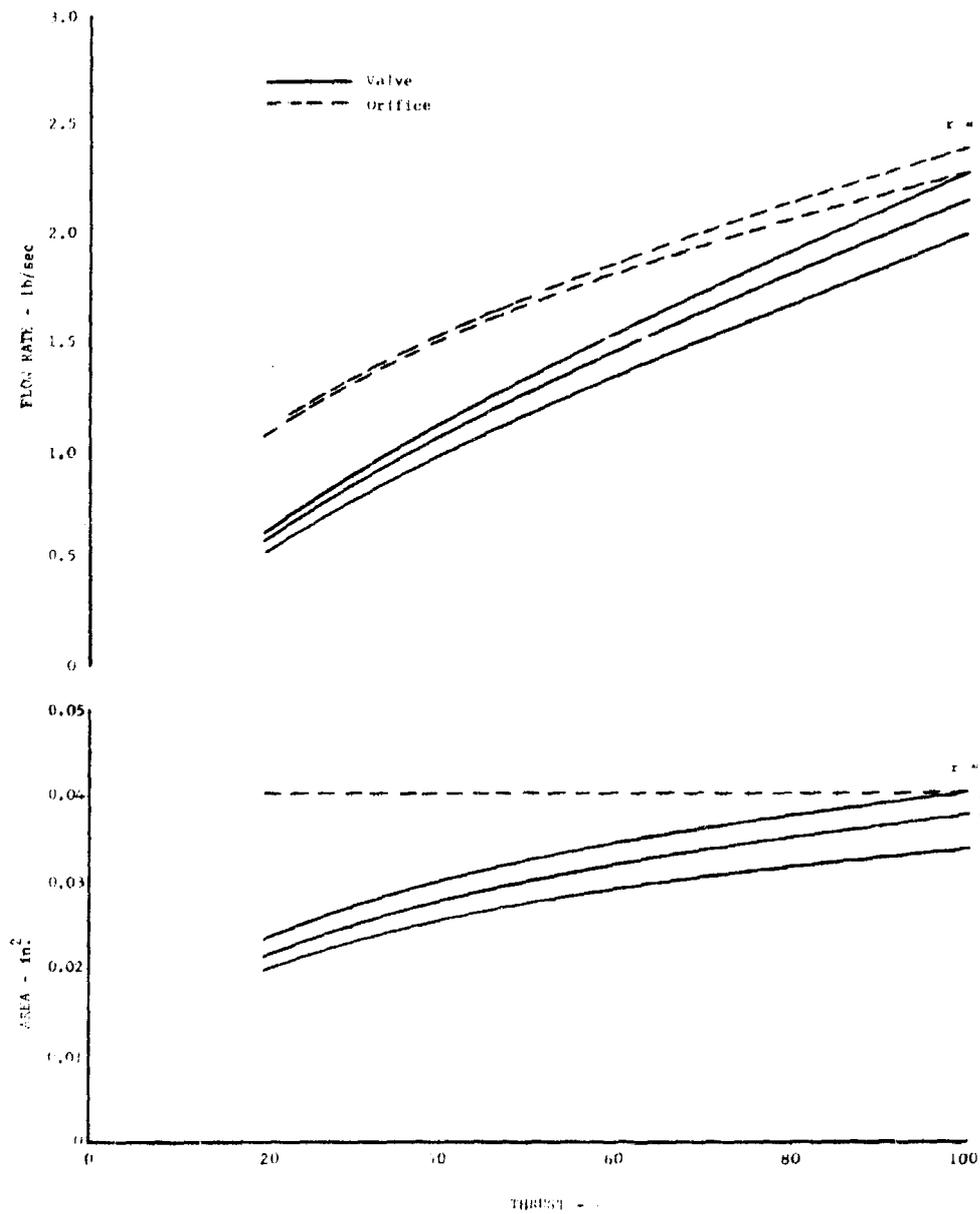
Figure 23. Effect of Pump Interstage Tapoff Location on Light-weight Heat Exchanger Coolant Valve DF 65466

The engine characteristics with the three candidate locations are presented in figures 23 through 28.

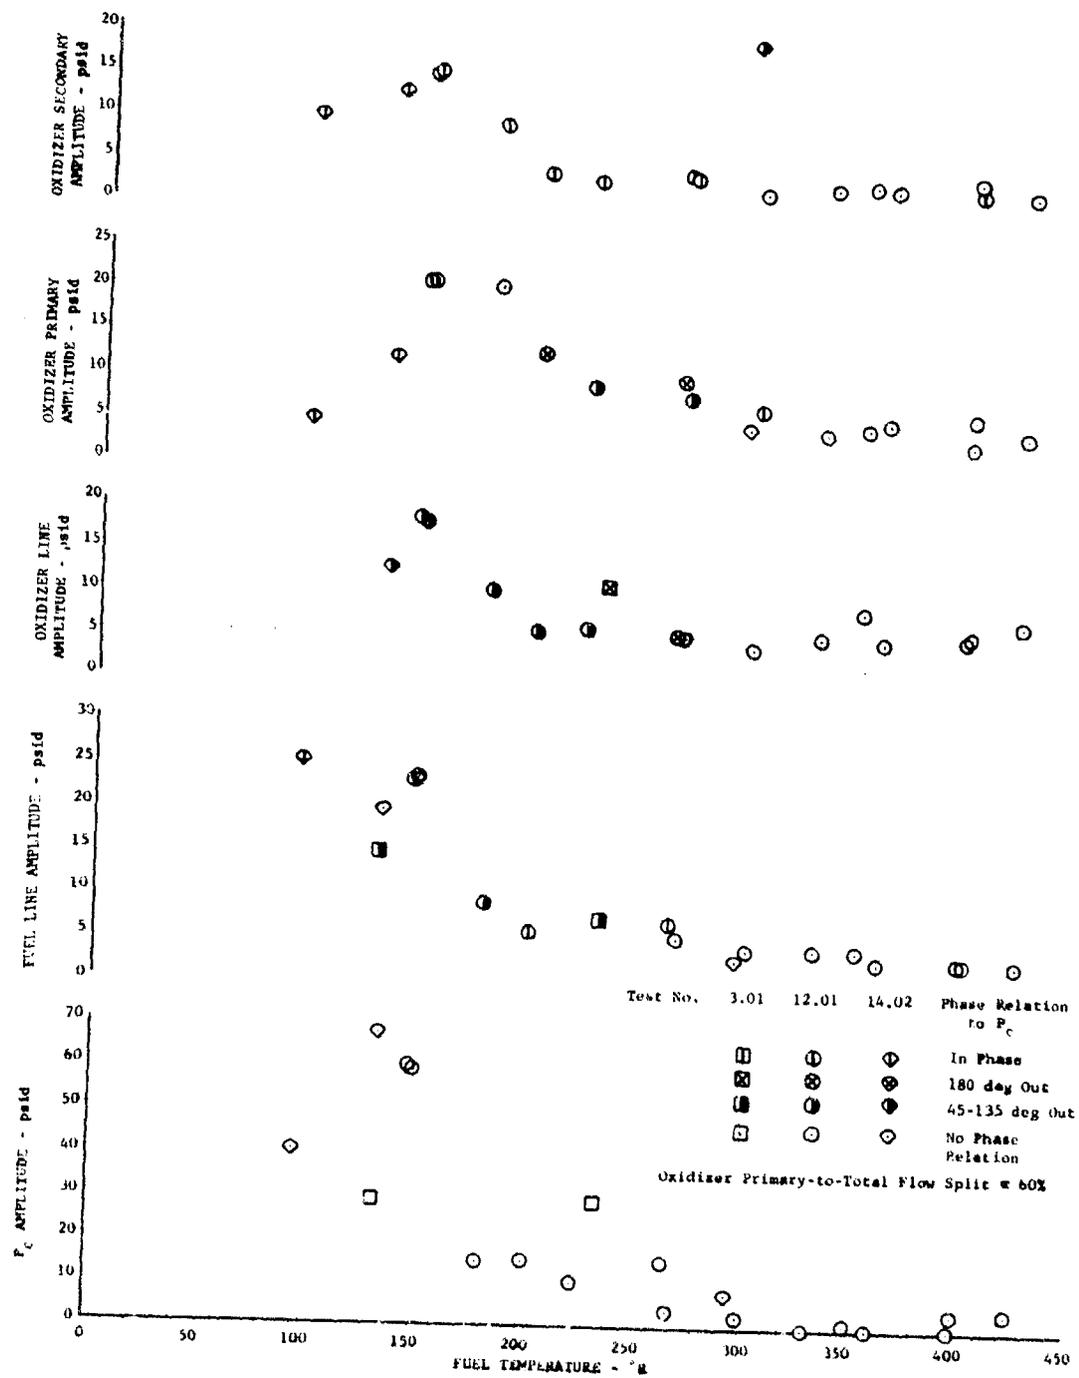
Figure 75. Fuel Temperature Effect on Amplitude

During test 12.01, the fuel injector temperature at 20% thrust was varied extensively. Figures 75, 76, and 77 are traces that show the path and the effects of fuel temperature on the amplitude and frequency of the combustion instability. The phase relationships are also indicated in figures 75, 76, and 77. The only two consistent phase relationships observed were that the secondary oxidizer cavity is in phase with the chamber oscillations and the fuel manifold is 180 deg out of phase with the combustion chamber. It is not understood what bearing this particular phase relationship has on the stability problem. However, the frequency of the parameters was not always equal at a particular fuel temperature. When frequencies are not equal, the phase relationship between the parameters is constantly changing, which lessens the significance of phase relationships. Another significant item is the large reduction in combustion chamber amplitude at fuel temperatures above 180°R.

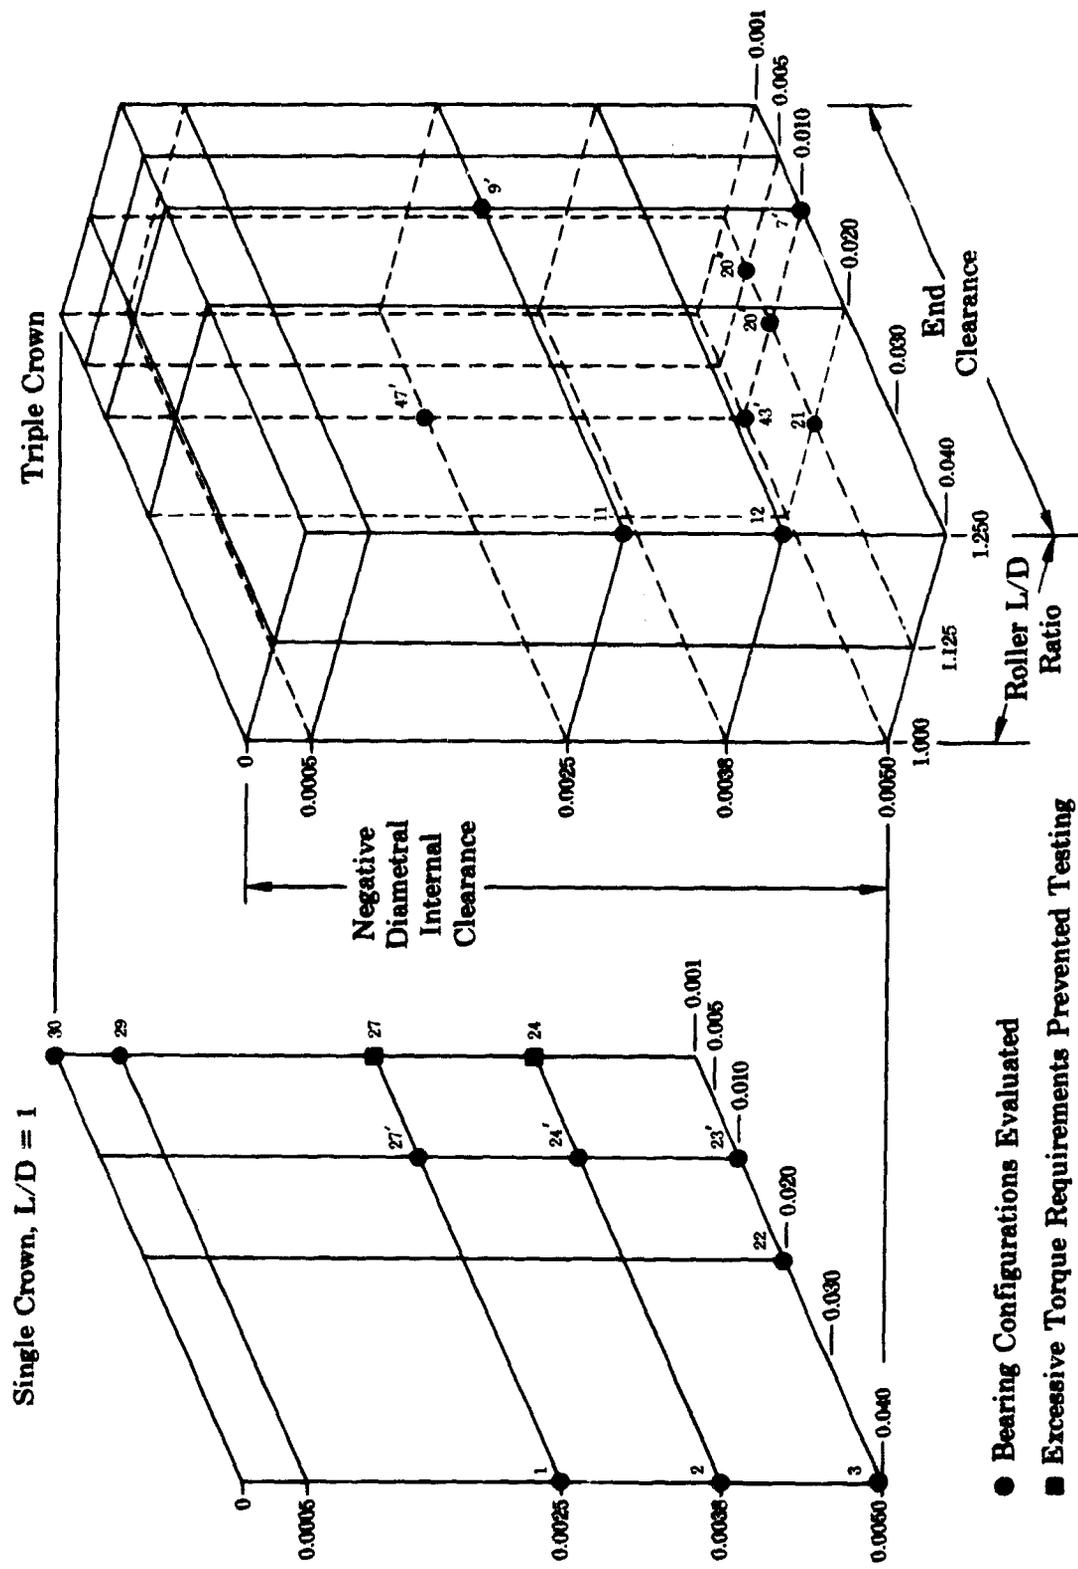
Figure 90. Roller Bearing Test Matrix

Based on the roller bearing tests, it appears that both roller end wear and skewing can be minimized or eliminated by increasing the negative diametral internal clearance and increasing the side rail clearance over the normally used values. The 0.005 in. tight fit of the outer race on the rollers is the negative diametral clearance required to maintain a load on the rollers on the unloaded side of the bearing, when the bearing is operating at design conditions and fabricated from stainless steel alloy (AMS 5630). Roller skewing, which accounted for most of the bearing failures during the current program, was not found to be related to roller end wear or roller end-to-side rail clearance if sufficient negative internal clearance was incorporated in the bearing.

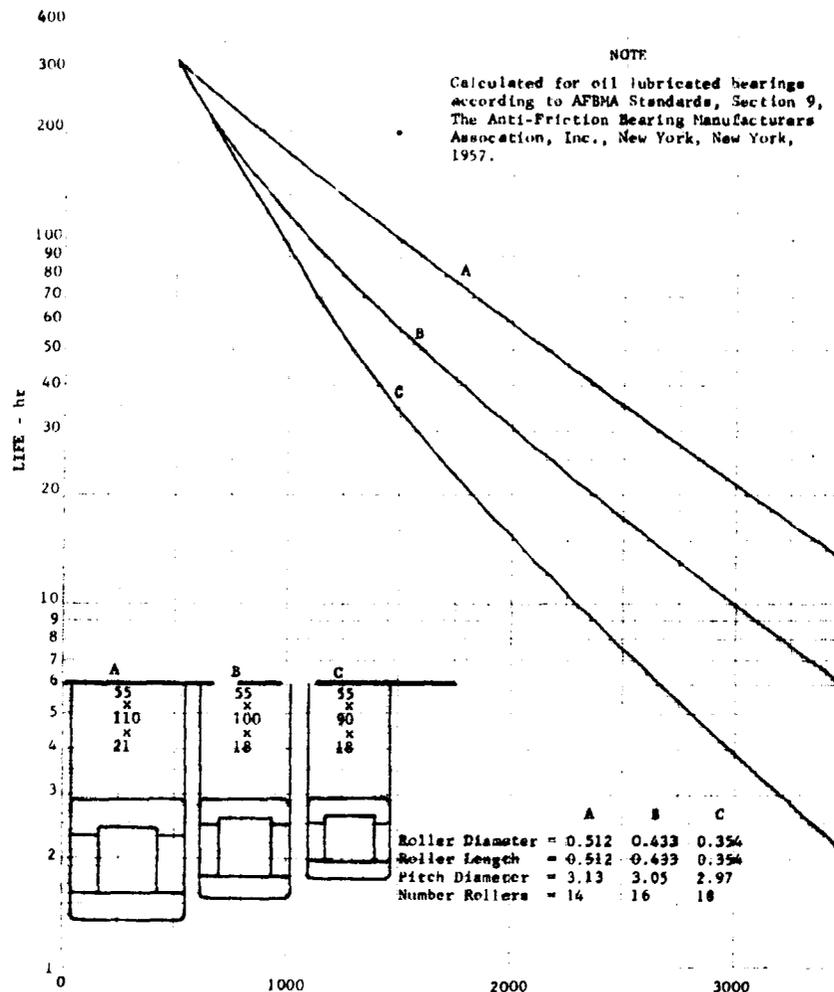
Figure 91. Roller Bearing Fatigue Life vs Radial Load DF 52756 (50,000 rpm)

loads and ensuring that the rollers are never completely unloaded. This negative internal clearance also provides more rotor restraint and reduces the hydraulic-mechanical vibrator interchange on the turbopump.

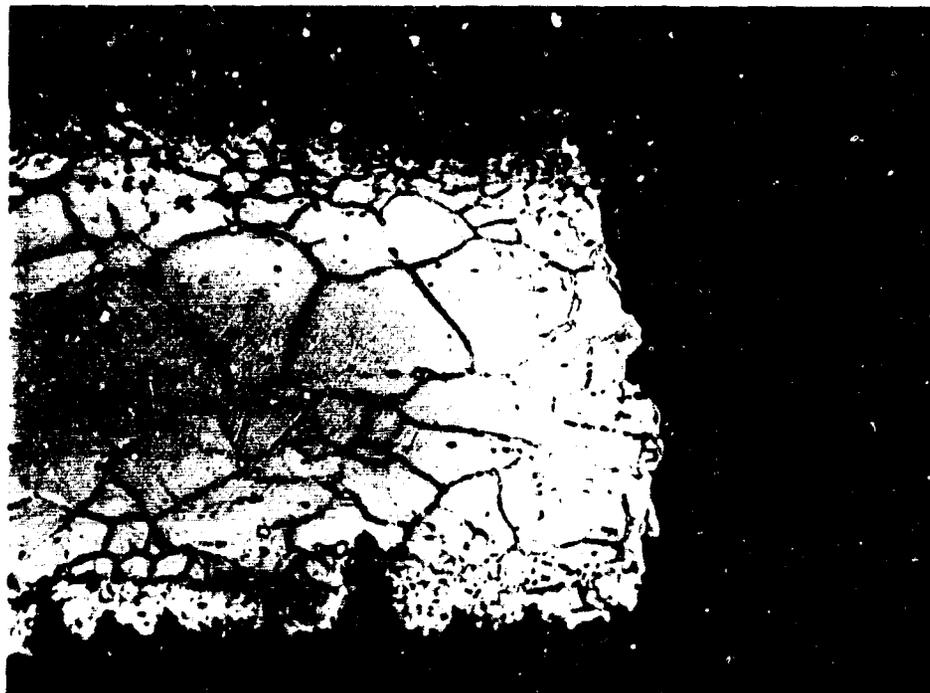
Figure 229. Crack in 0.005 in. Thick Inconel
625 (AMS 5599) After Etching
(500X Magnification)

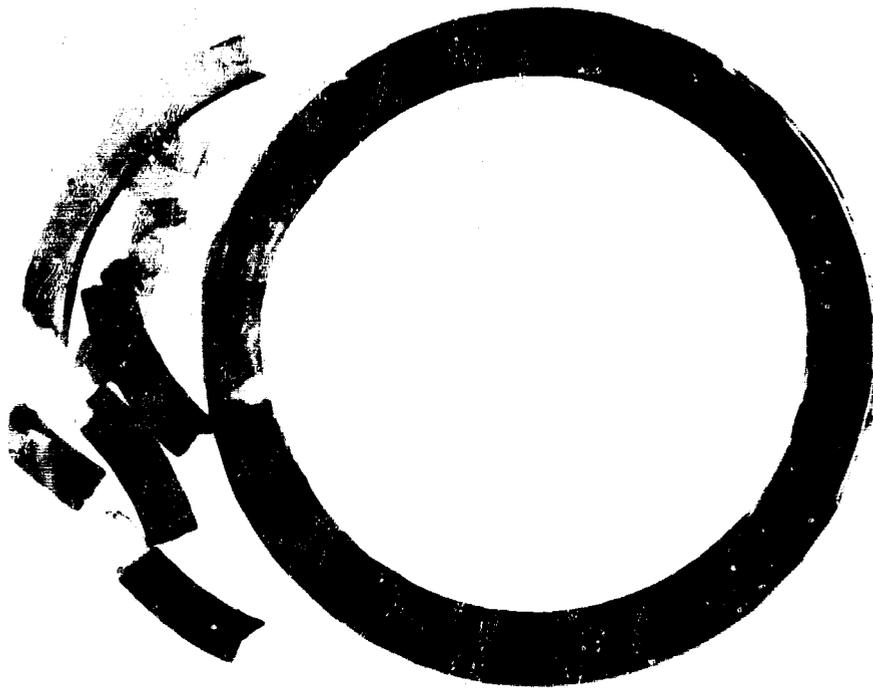
Figure 244. Failed Portion of Disk Seal After Test

1. The primary lip seal was in good condition with negligible wear.
2. A section of the disk seal had failed as shown in figure 244 and was found in the outlet housing. One disk seal axial support ring was bent as shown in figure 245.
3. The shaft disk outside diameter was scored where it contacted the bent support ring.
4. Contamination particles were embedded in the Teflon coating of the outlet flange primary O-ring static seal.

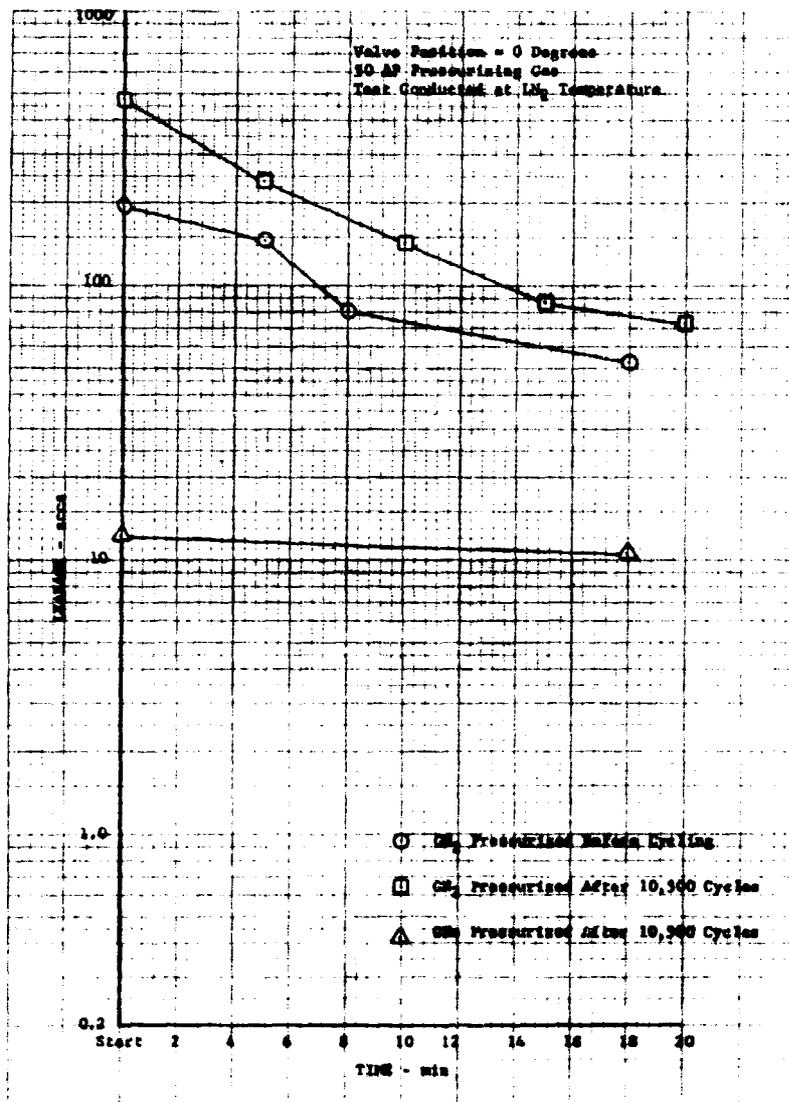
Figure 248. Hoop-Type Disk Seal Leakage vs Time, DF 65061
 Rig F-35106-6

Indicated disk seal leakage was somewhat unstable and varied with time as shown in figure 248. The measurements were apparently affected by variations in vent line vaporization rates due to both variable flowrates and cooling bath levels. The values shown on figure 249 are the final readings taken at each point. After the endurance test was completed, an additional 100 shutoff cycles were performed using helium as the pressurizing and leakage test fluid to improve stability. During these tests, the valve position for minimum leakage was found to be 3.2 deg from the full closed position. The test results using helium as the pressurizing medium and with the valve at 3.2 deg open are shown in figure 250.

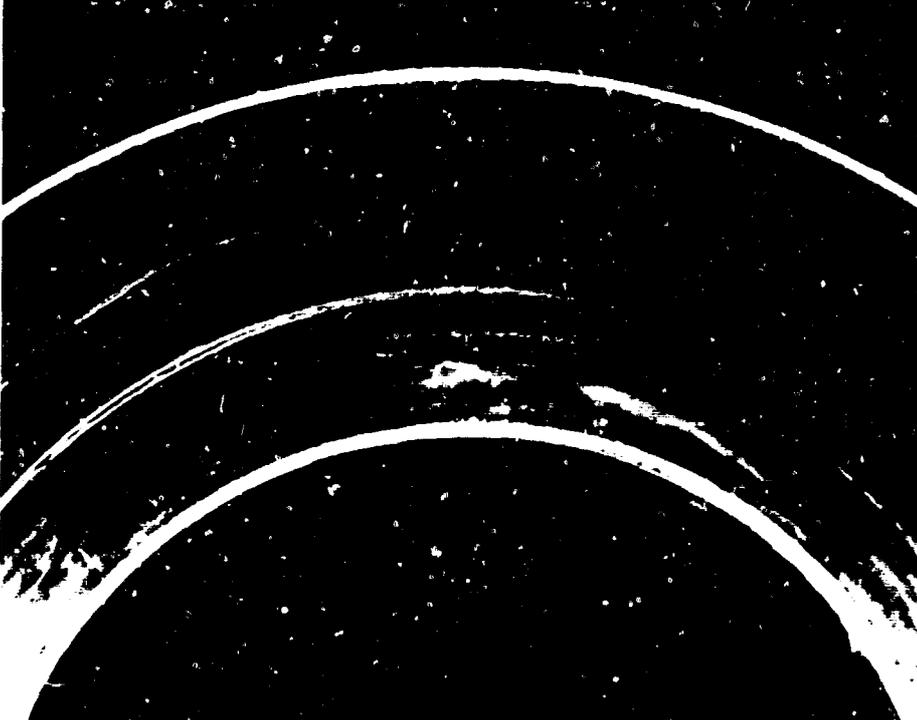
Figure 322. Primary Shaft Lip Seal After
Test of Build 10B

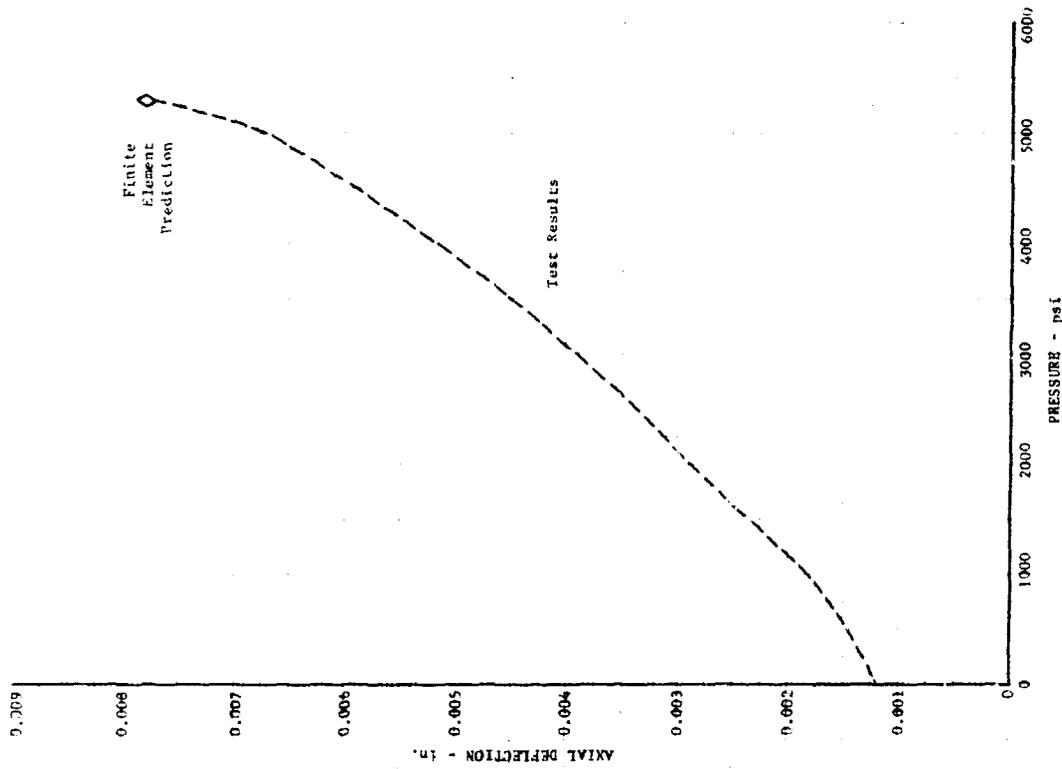
Figure 349. Axial Deflections at ID of Flange Rig 35120-3
